Woods Hole Village Climate Change Vulnerability Assessment and Adaptation Plan

October 2020

PREPARED FOR:
Woods Hole Oceanographic Institution
Marine Biological Laboratory
NOAA Northeast Fisheries Science Center

PREPARED BY:
Woods Hole Group, Inc.
A CLS Company
107 Waterhouse Road
Bourne, MA 02532 USA

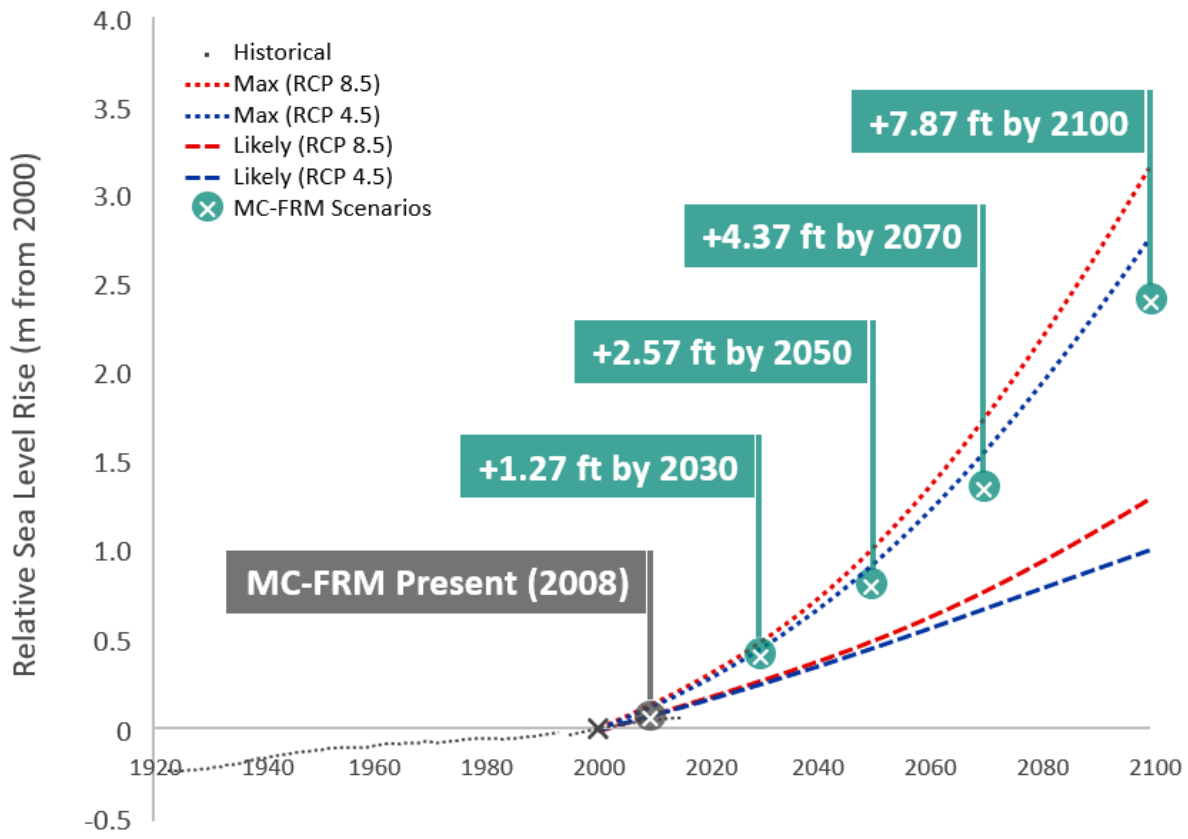
Figure 2-4 Relative sea level rise projections

The “High” scenario projections developed for MC-FRM (Figure 2-4) and applied to the NOAA tide gage at Woods Hole (Table 2-1) are the basis for MC-FRM inputs and this project’s nuisance flooding evaluation.

For this reason, the sea level rise projections used for this study may be treated as ranges of possible impacts over periods of time. Conservatively selecting the “High” scenario (MC-FRM Scenario in Figure 2-4) allows for the evaluation of inundation risk probabilities under other scenarios due to the bracketed nature of the results. For example, the “High” results in 2030 are approximately equivalent to “Intermediate/Likely” results in 2050, and the “High” results in 2050 are approximately equivalent to the “Intermediate/Likely” results in 2070. In this way, the selected scenarios provide an upper bound of potential risk. This approach enables projections to be used as guidelines for investment decisions based on the knowledge to date, while providing flexibility to accommodate these uncertainties.

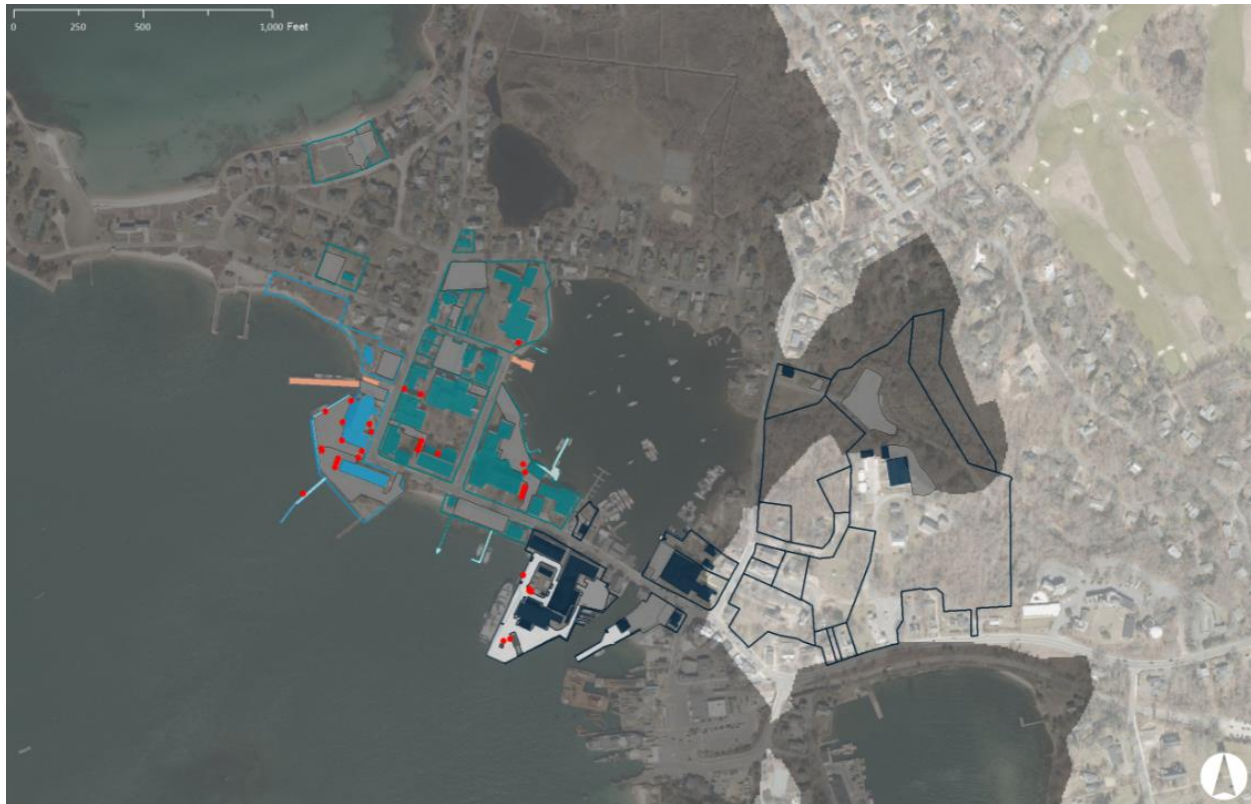
Figure 2-6 MC-FRM extent of model mesh used to select WHOI/MBL/NOAA assets for vulnerability assessment

The project team developed an inventory of institutional assets for WHOI, MBL and NOAA that included buildings, associated infrastructure components (e.g. generators, fuel tanks, electrical equipment, fixed cranes), parking lots, and coastal infrastructure (docks and piers) on the Woods Hole Village campuses of each organization. While MBL and NOAA property in Woods Hole fall entirely within the zone of potential flooding, some parts of WHOI’s campus are elevated and not vulnerable to future flooding. Before engaging in asset-specific analyses, the project team pre-screened assets to reduce unnecessary investigations. Any asset that did not intersect with the extent of the MC-FRM model mesh was dropped from the vulnerability and risk assessment. Figure 2-6 shows the asset screening process.

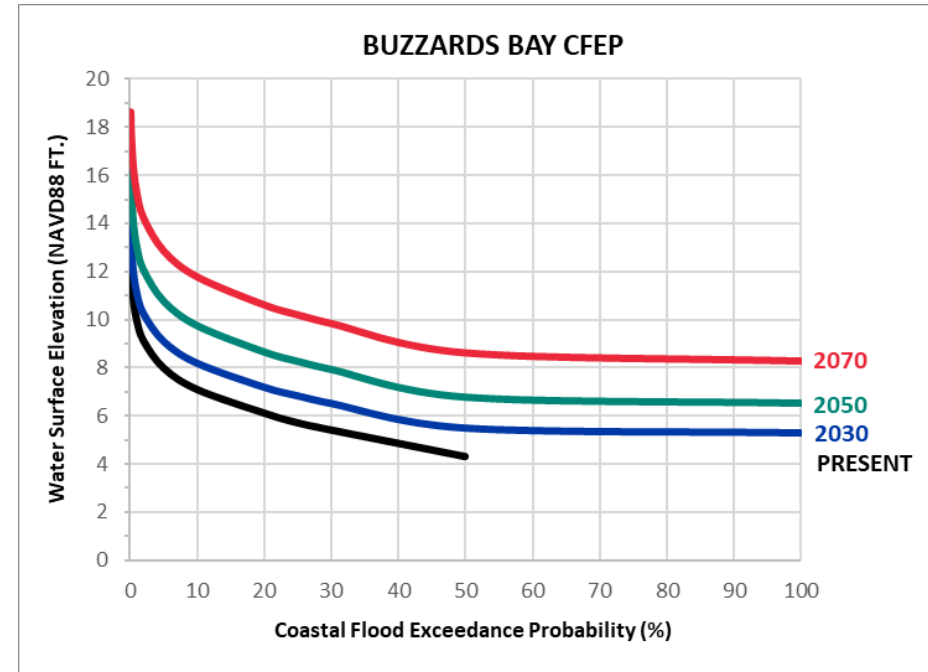
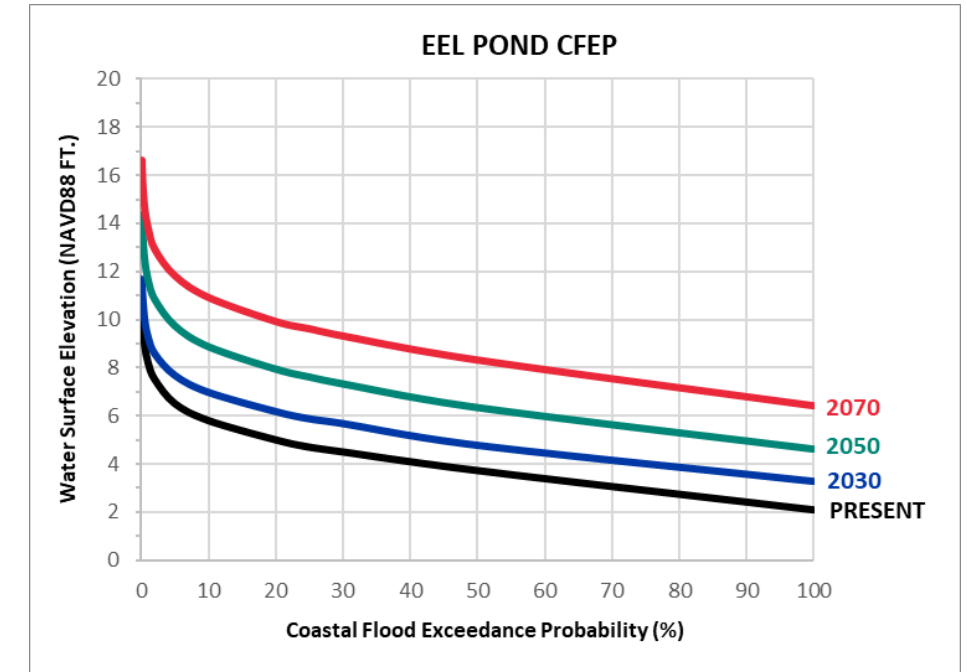
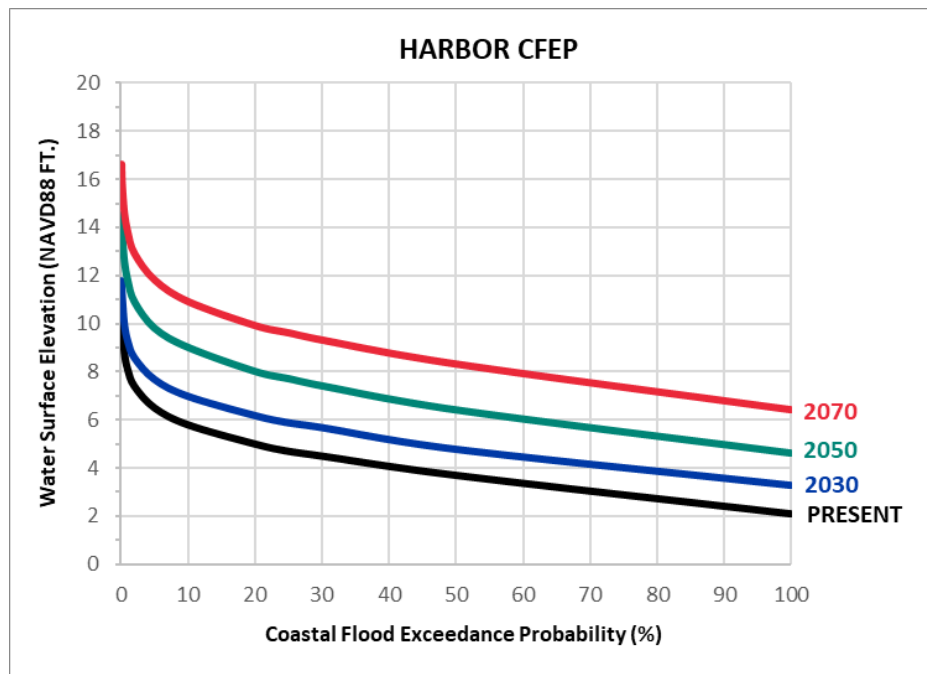
Probability of exceedance data – the probability that storm surge will exceed the critical elevation of the asset – was developed for each asset for Present, 2030, 2050 and 2070 planning horizons. Since WHOI/MBL/NOAA assets are located throughout the Woods Hole Village study area, they are exposed to different CFEP profiles, depending on location. Therefore, the project team identified representative MC-FRM nodes (a node is a point in the model at which the governing equations are solved) to analyze asset exposure in a spatially discrete manner. Woods Hole Group reviewed nodal CFEP distribution curves in the vicinity of study assets (see Figure 2-1 for distribution of all nodal points in the study area) to select a subset of individual nodes that best represent the flood exposure profiles for assets in different regions of Woods Hole Village. Figure 2-7 shows the areas and assets covered by each of the five (5) representative MC-FRM nodes. Figures 2-8 through 2-12 present the CFEP distribution curves for each of these nodes.

Figure 2-8 MC-FRM node – Buzzards Bay

Figure 2-9 MC-FRM node – Eel Pond

Figure 2-10 MC-FRM node – Harbor

Figure 2-11 MC-FRM node – School Street

Figure 2-12 MC-FRM node – The Square

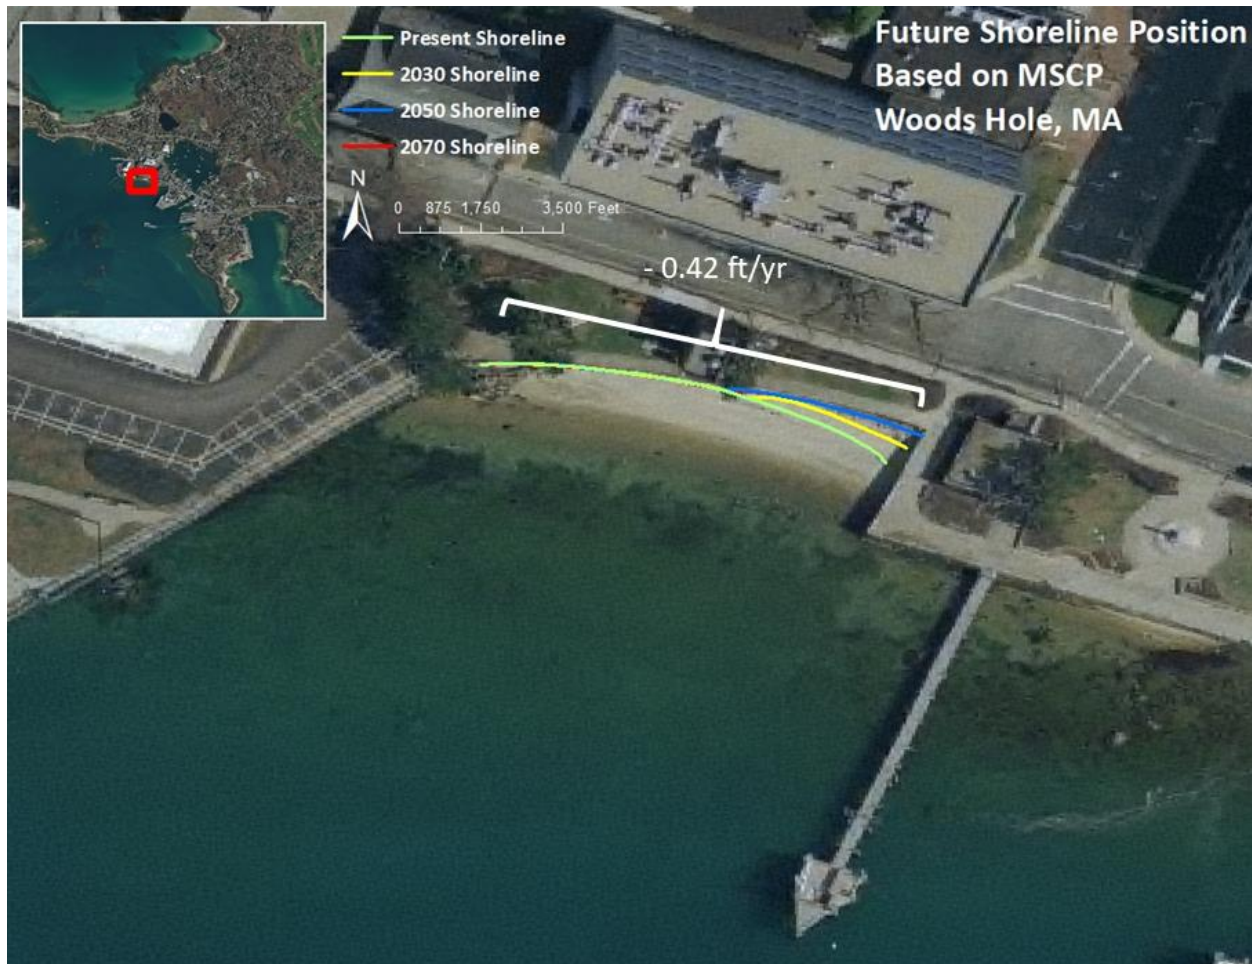
B-4 Shoreline Projections – Water Street

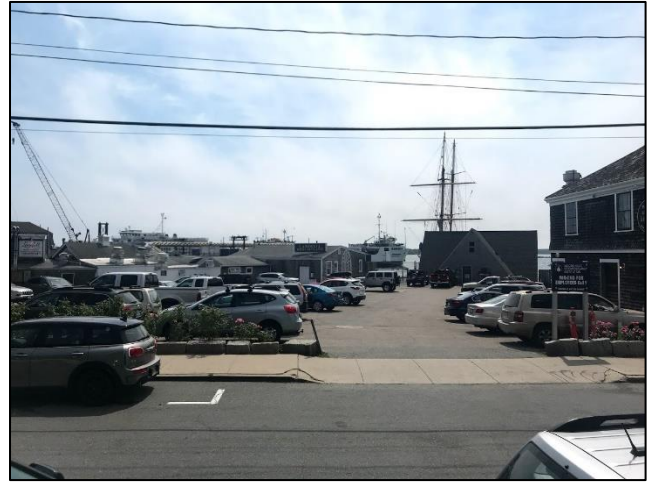
Dyers Parking

Asset Type: Parking Lots and Parks

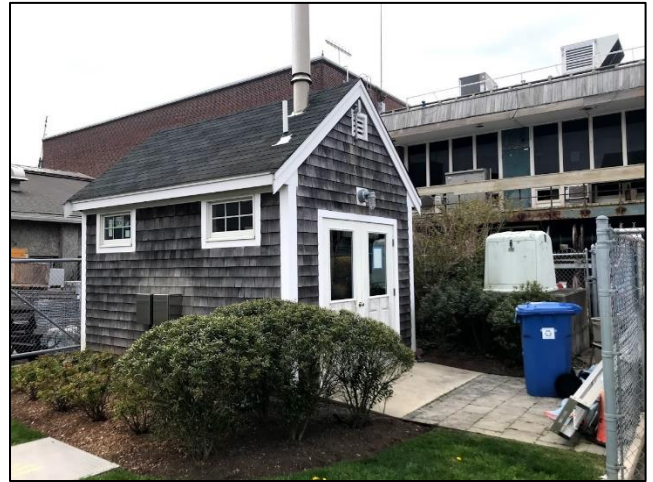
Iselin Sewer Pump Shed

Asset Type: Buildings

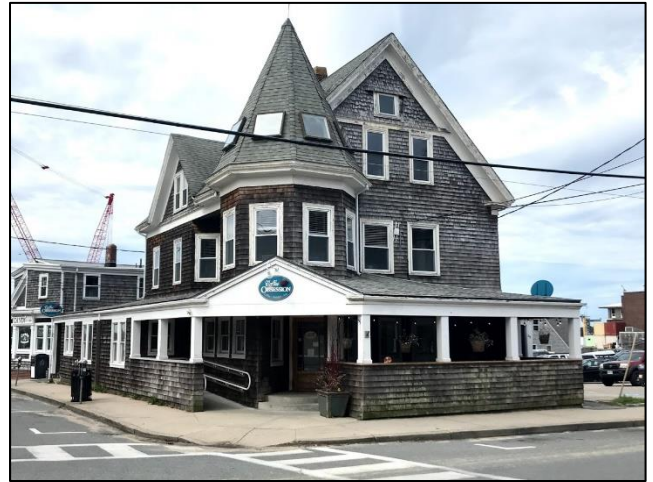
38 Water Street

Asset Type: Buildings

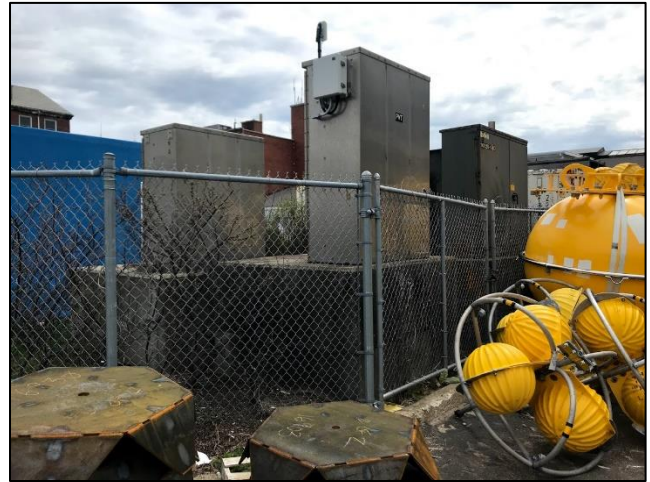
Iselin Transformers 1/2/3

Asset Type: Infrastructure

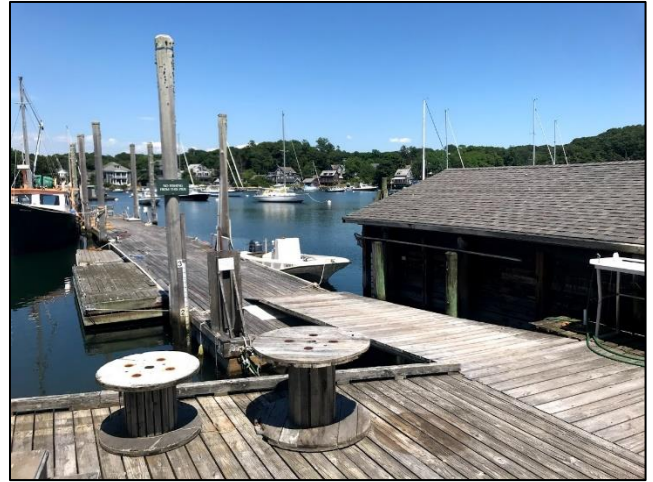
MRC Dock

Asset Type: Coastal Infrastructure

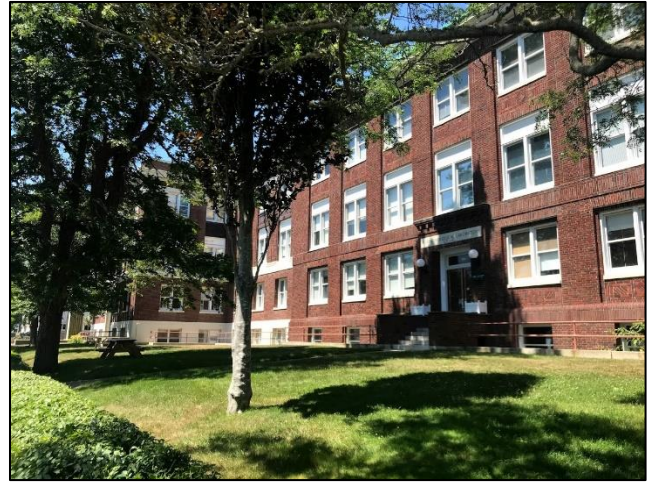
Lillie Laboratory

Asset Type: Buildings

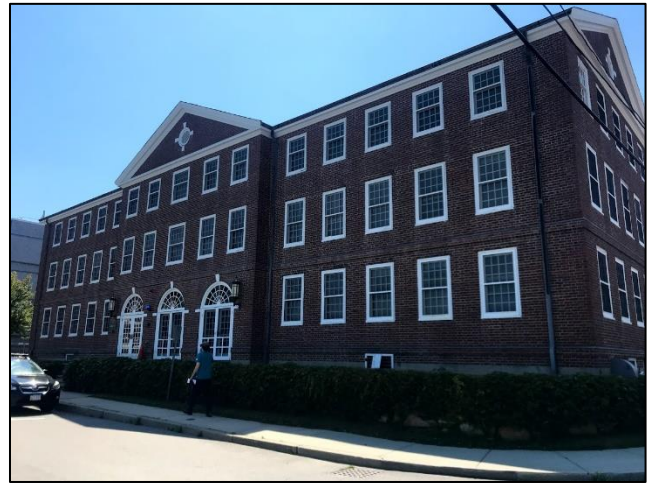
Ebert Hall

Asset Type: Buildings

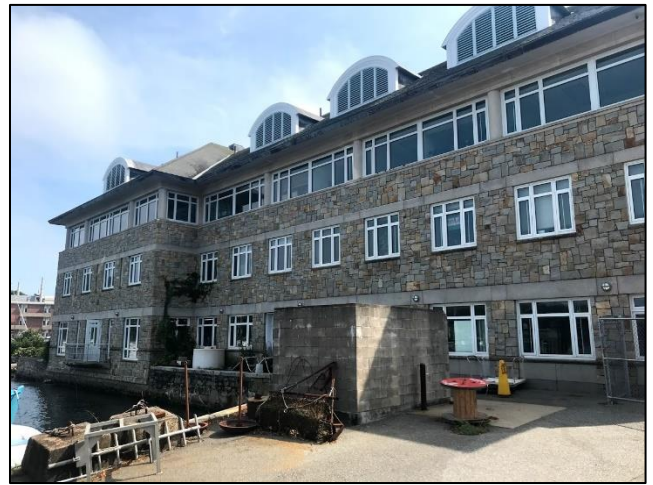
Marine Resources Center

Asset Type: Buildings

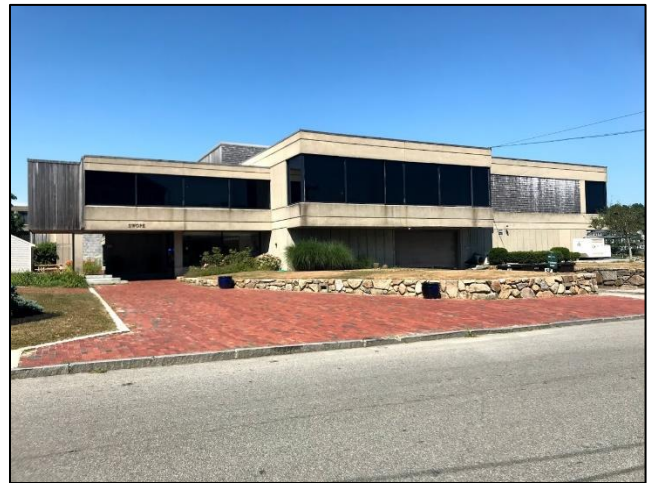
Swope Building

Asset Type: Buildings

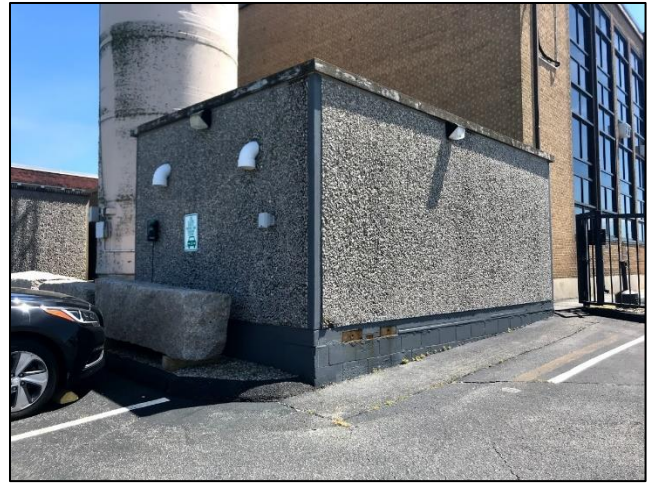
Seawater Pump House

Asset Type: Infrastructure

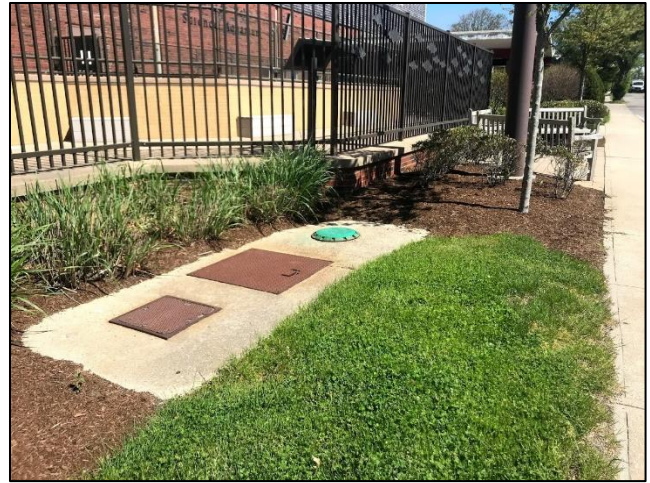
UST

Asset Type: Infrastructure

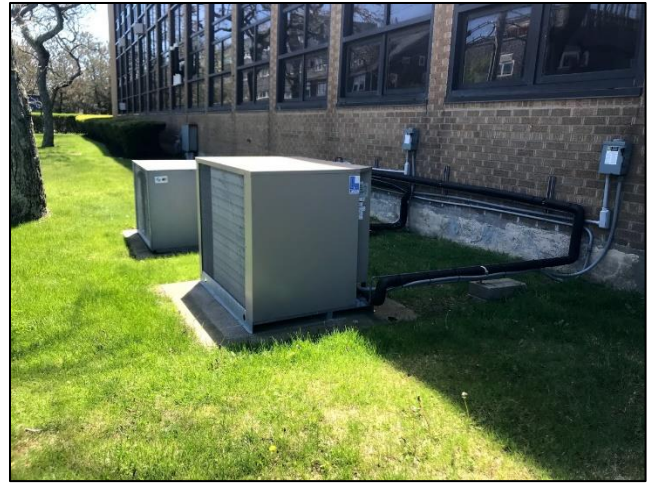
Main Office A/C Units

Asset Type: Infrastructure
