# Resilient Woods Hole

Joe Famely, Climate & Sustainability Team Lead  
Woods Hole Group

# ResilientWoodsHole Phase 1

Climate Change Vulnerability Assessment (WHOI/MBL/NOAA)

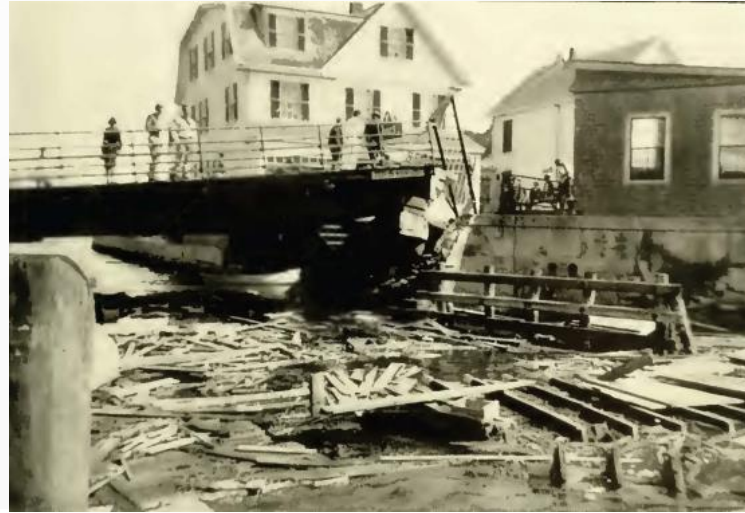
*Wreckage in Great Harbor at the entrance to Eel Pond, note the damaged foundation of the drawbridge*

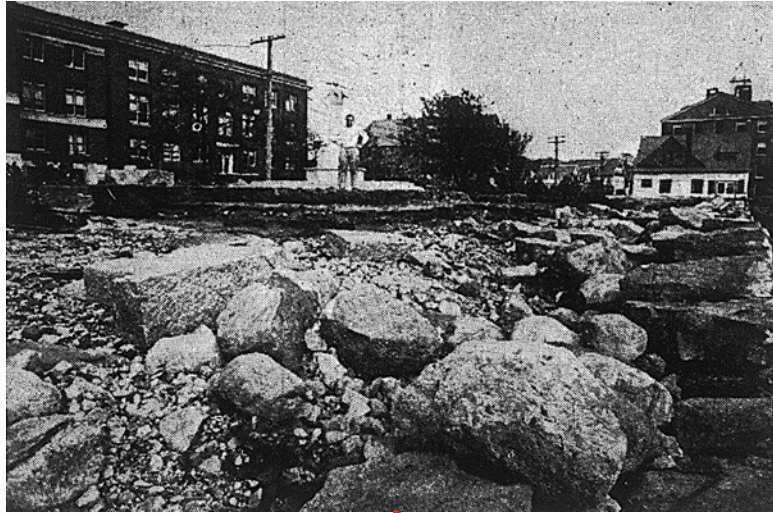
Wreckage of seawall facing Marine Biological Laboratory (Falmouth Enterprise)

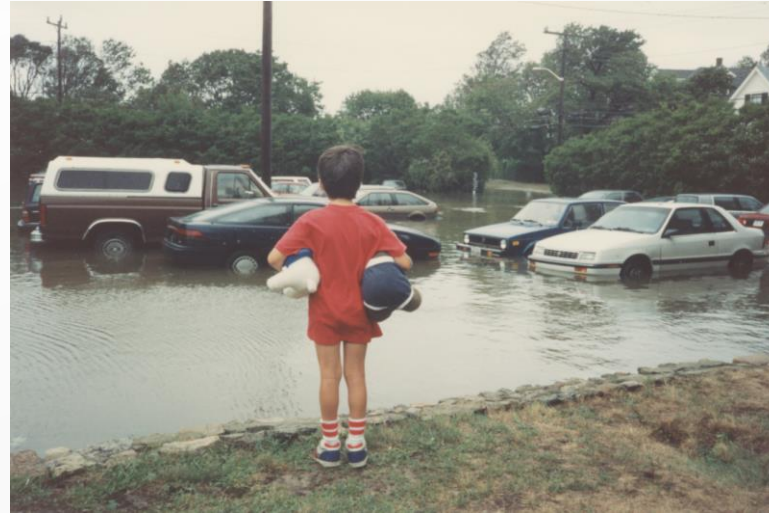
Post-storm flooding along Millfield Street

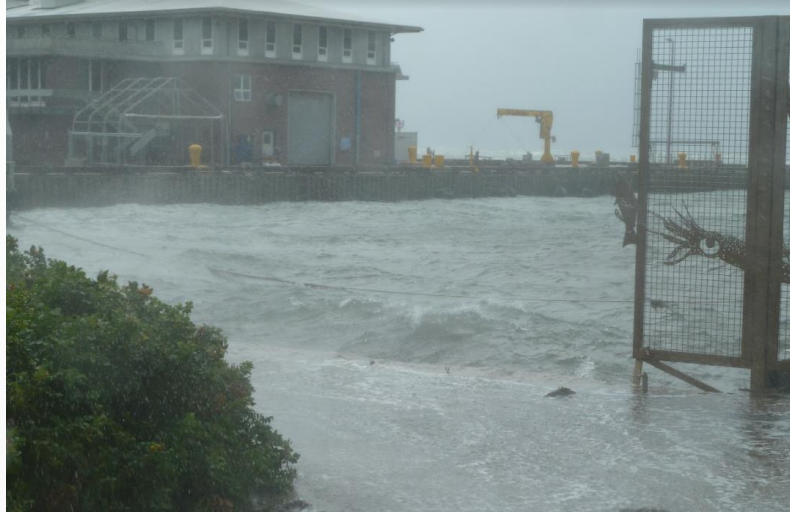
Wave overtopping at Waterfront Park

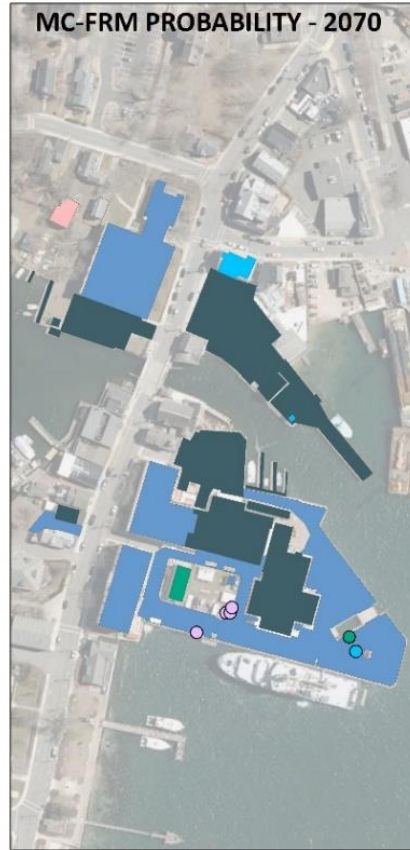
MC-FRM PROBABILITY - 2070

## Iselin

Critical Elevation (CE): 6.08 FT. NAVD88

North Alvin high bay 1300 Door - systems at grade  
Room 138 (prior survey)

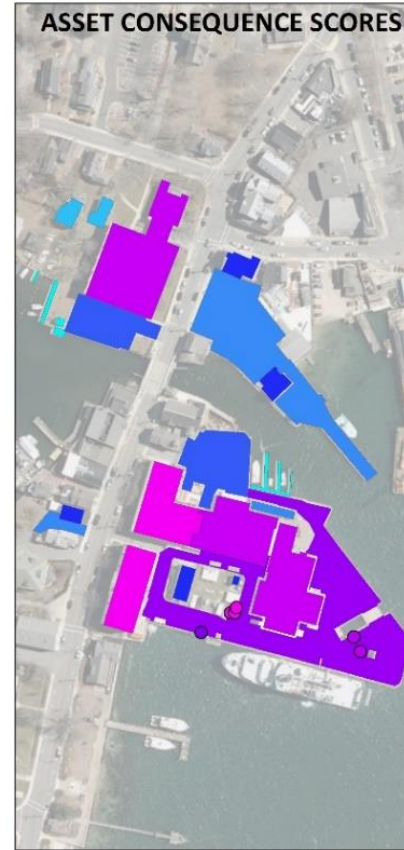
ASSET CONSEQUENCE SCORES

Scores	Direct Impacts			Mission Impairment			Sum	Consequence Score
	Service Loss Extent	Service Loss Duration	Cost of Damage	Research & Applied Science	Operations & Economic Activity	Education & Outreach		
	4	4	3	3	4	2	20	83

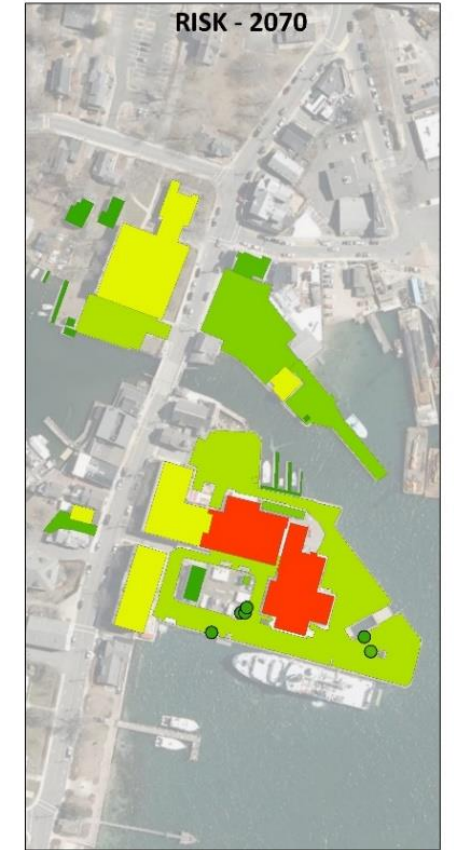
RISK - 2070

Time horizon	Probability of Exceedance	Consequence Score	Risk Score	Risk Rank
Present	5	83	417	8/36
2030	20		1667	4/36
2050	50		4167	-
2070	100		8333	-

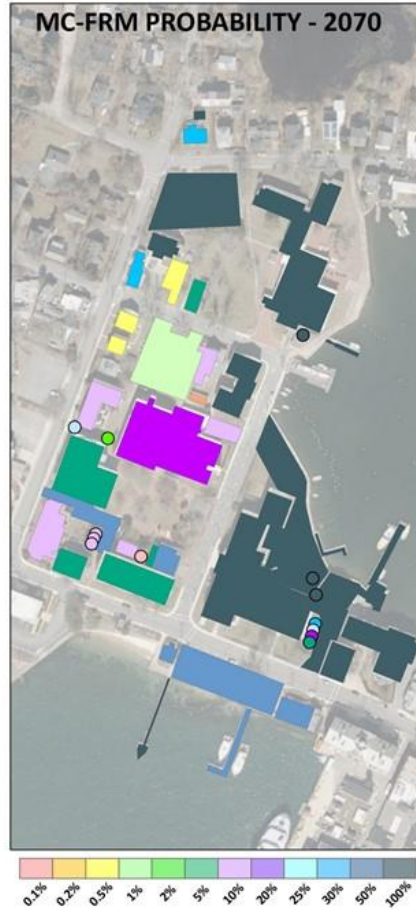
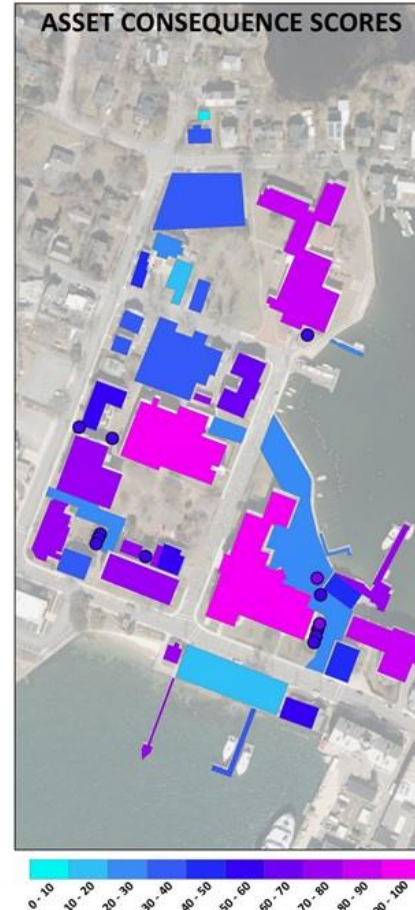
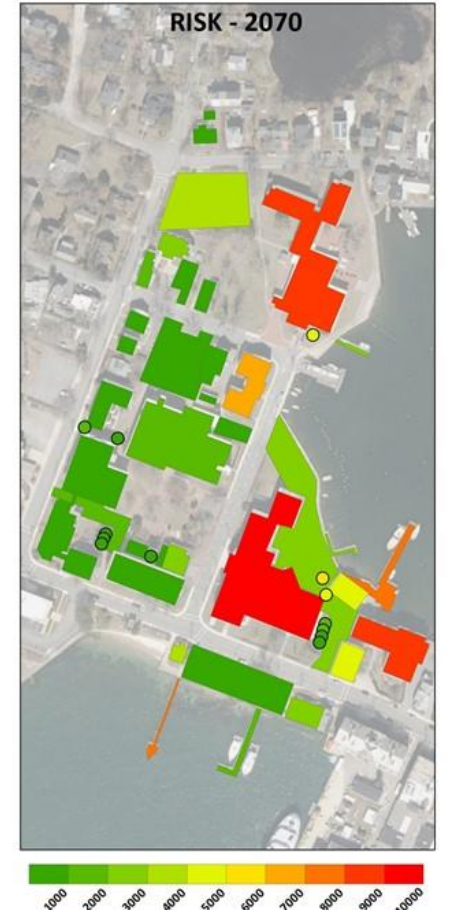
## Lillie Laboratory

Critical Elevation (CE): 5.17 FT. NAVD88

Loading dock slab entry from 2017 ELV CERT

Lillie Fuel Tank (5.30 FT. NAVD88), Lillie/MRC Junction Box (9.33 FT. NAVD88),

Lillie Transformer (9.89 FT. NAVD88), Lillie/MRC Meter Box (11.37 FT. NAVD88)

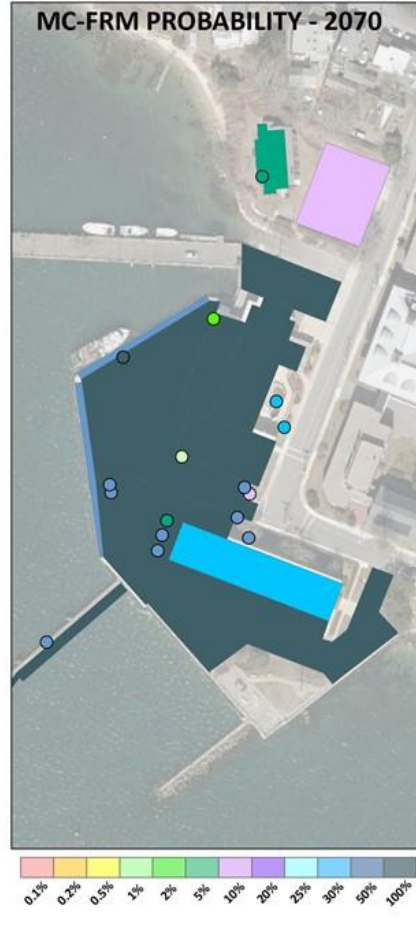
## Gear Shed

Asset Type: Buildings  
 Critical Elevation (CE): 5.09 FT. NAVD88  
 Threshold Description:  
 Grade at bay door (LIDAR)

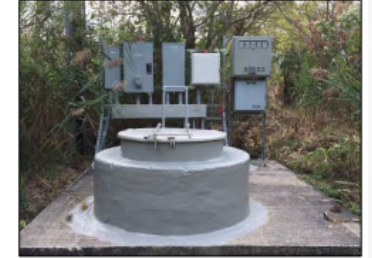
## Park Road Sewer Lift Station

Critical Elevation: 4.6 ft NAVD88

Threshold Description:

Top of raised tank; the critical elevation was obtained through a field-survey conducted by the Town.

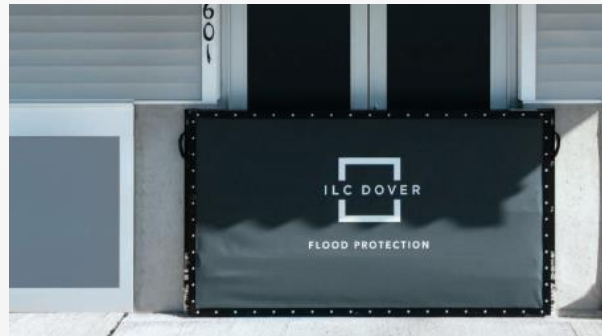
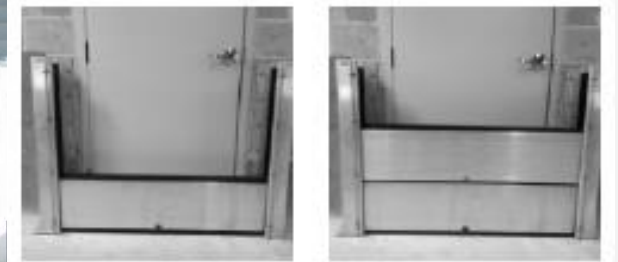
# MBL Seawater Pumphouse

Door to below grade pumps

48" high door barrier and exterior façade sealing

0.5%>0% / 2%>0% / 10%>0.5% / 50%>2%

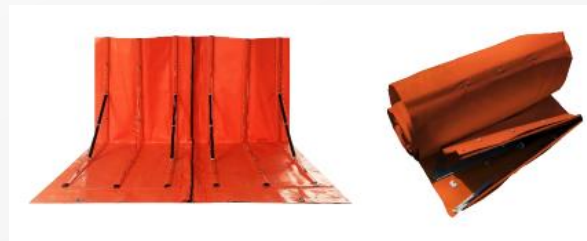
# NOAA Fisheries Aquarium

Vent from Aquarium basement 14" above Gear Shed floor  
36" high deployable barrier or masonry wall in Gear Shed  
5% > 1% / 10% > 2% / 50% > 10% / 100% > 50%

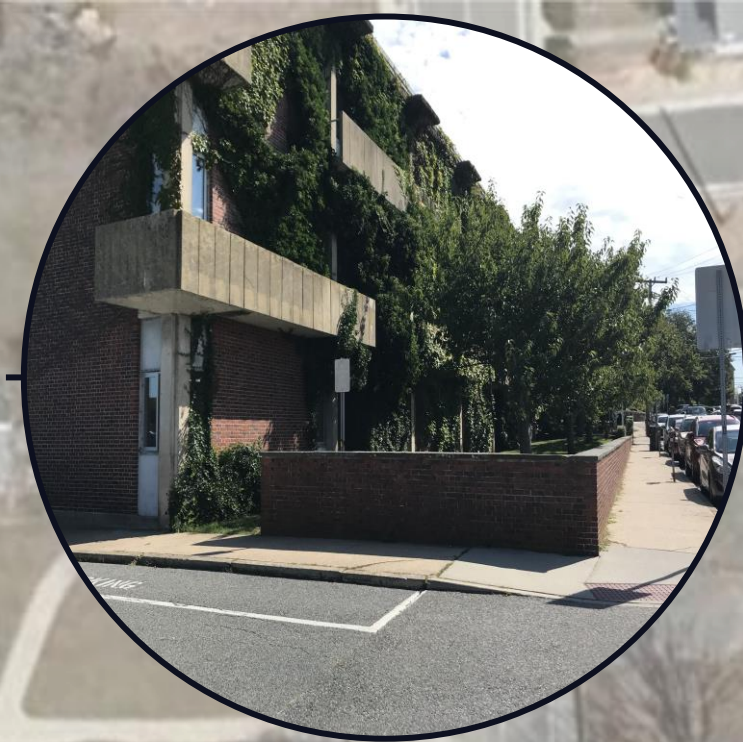
# Redfield Laboratory alternative a

tie-in to high ground >

7.3 FT NAVD88

Deployable barriers  
(~275 ft.)

Aquafence

Top of existing wall = 11.3 FT NAVD88

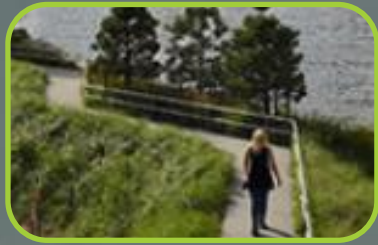
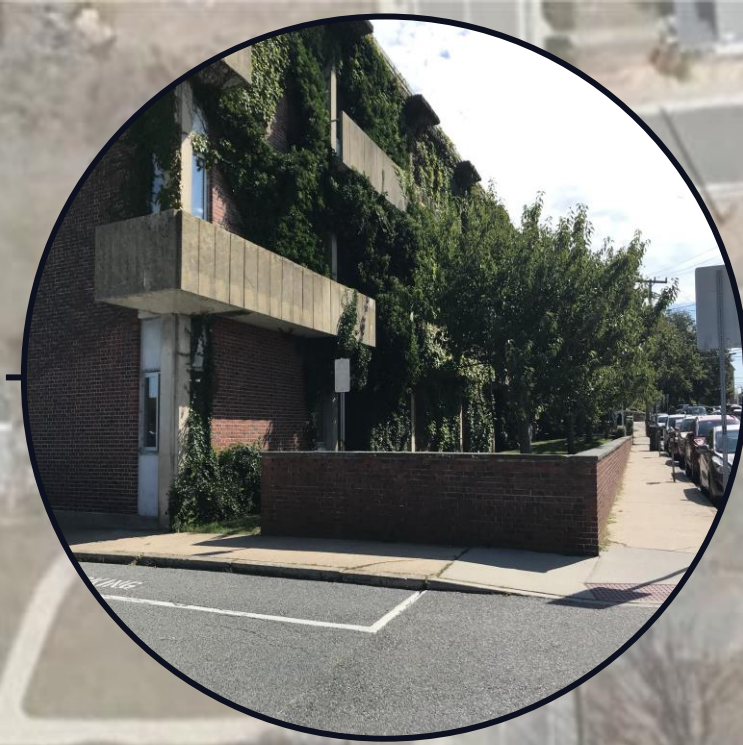
# Redfield Laboratory

*alternative b*

Elevated berm park  
11.3 FT  
NAVD88

tie-in to high  
ground >

7.3 FT NAVD88

Level pond side of parking  
lot to Redfield grade

~4 ft wall to  
match existing

passive barrier

Top of existing wall = 11.3 FT NAVD88

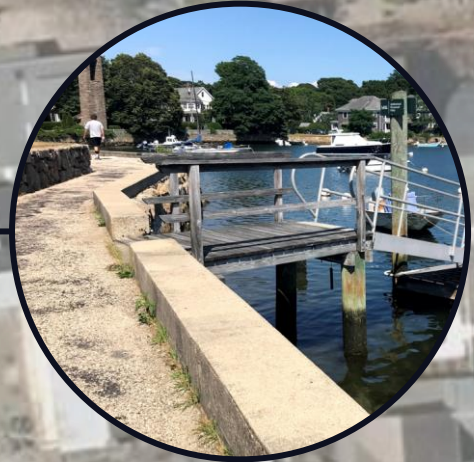
Swope/Ebert  
alternative a

5.3 FT NAVD88

Elevate sidewalk to Swope grade

7.6 FT NAVD88

<tie-in to high ground

11.6 FT NAVD88 berm walkway

11.6 FT NAVD88 terraced area

passive barrier

walkovers

~4 ft parapet wall

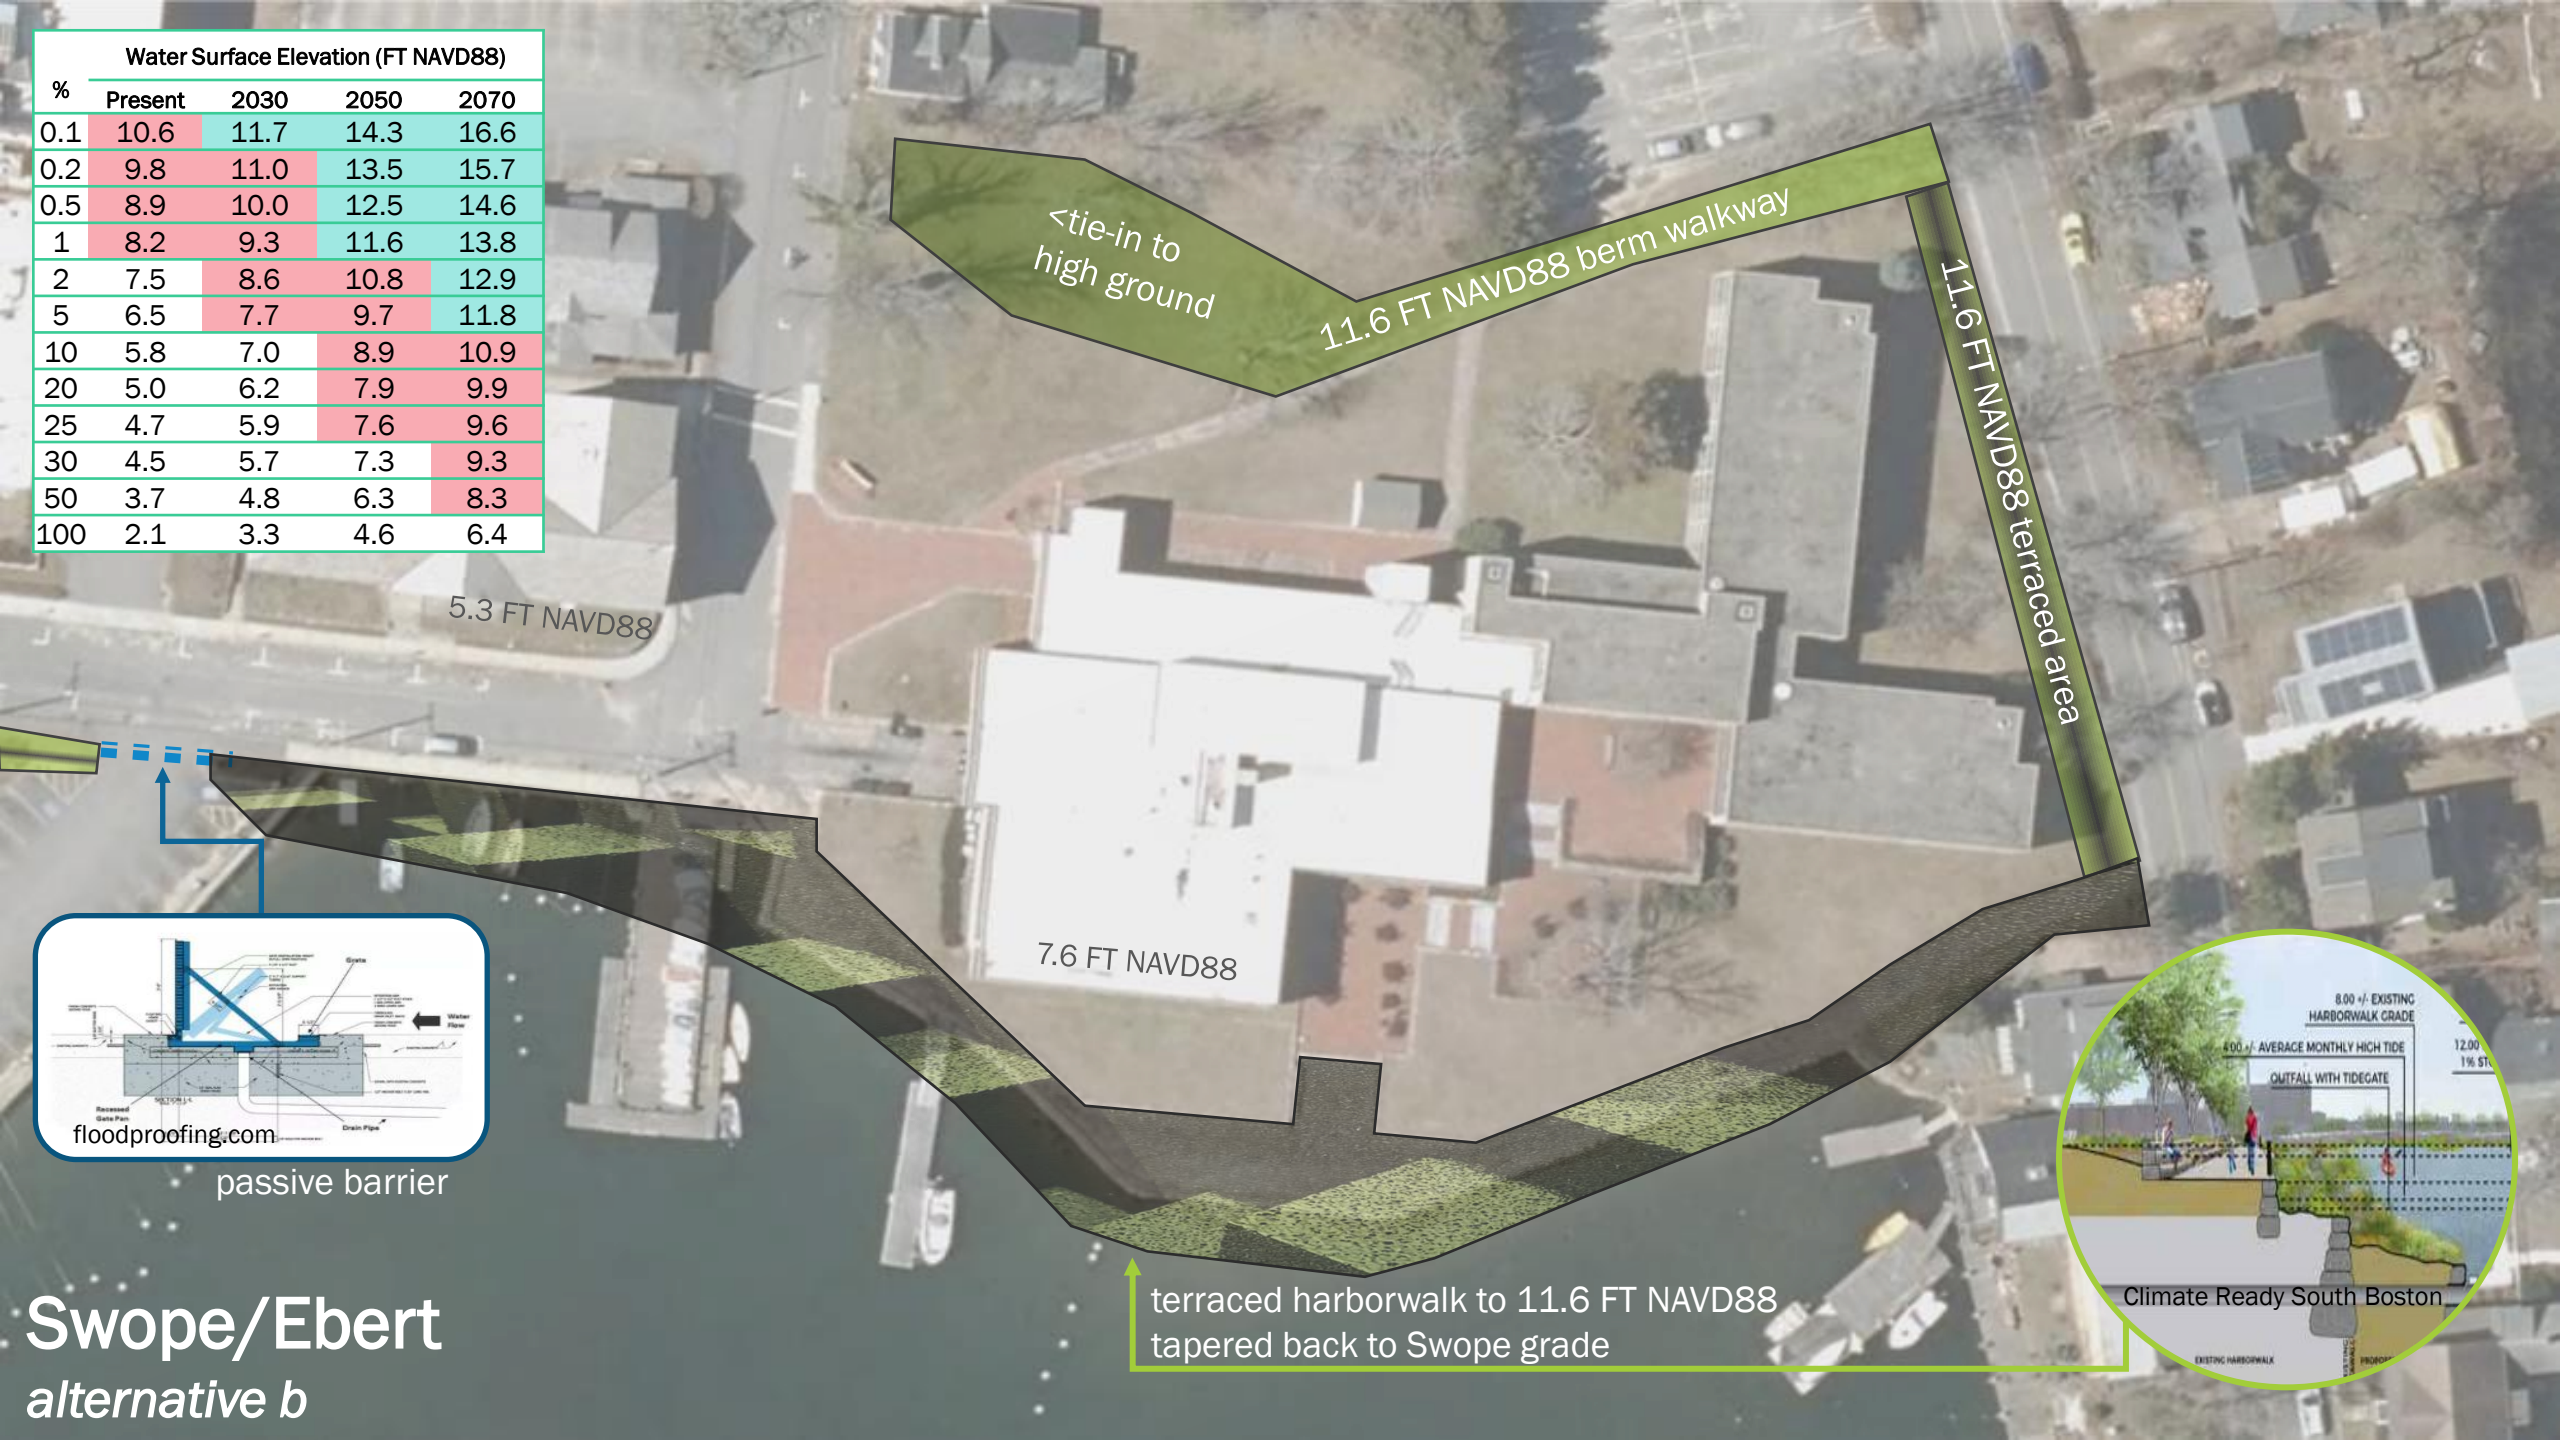
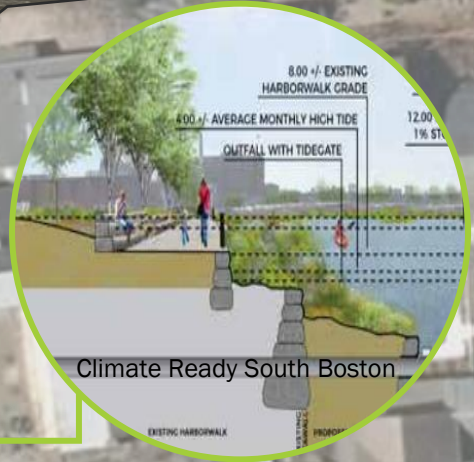
Swope/Ebert  
alternative b

passive barrier

terraced harborwalk to 11.6 FT NAVD88 tapered back to Swope grade
