Stoney Beach Restoration Alternatives Analysis

November 2023

PREPARED FOR:
ResilientWoodsHole
Woods Hole Oceanographic Institution
Marine Biological Laboratory
NOAA Fisheries

PREPARED BY:
Woods Hole Group, Inc.
A CLS Company
107 Waterhouse Rd
Bourne, MA 02532 USA

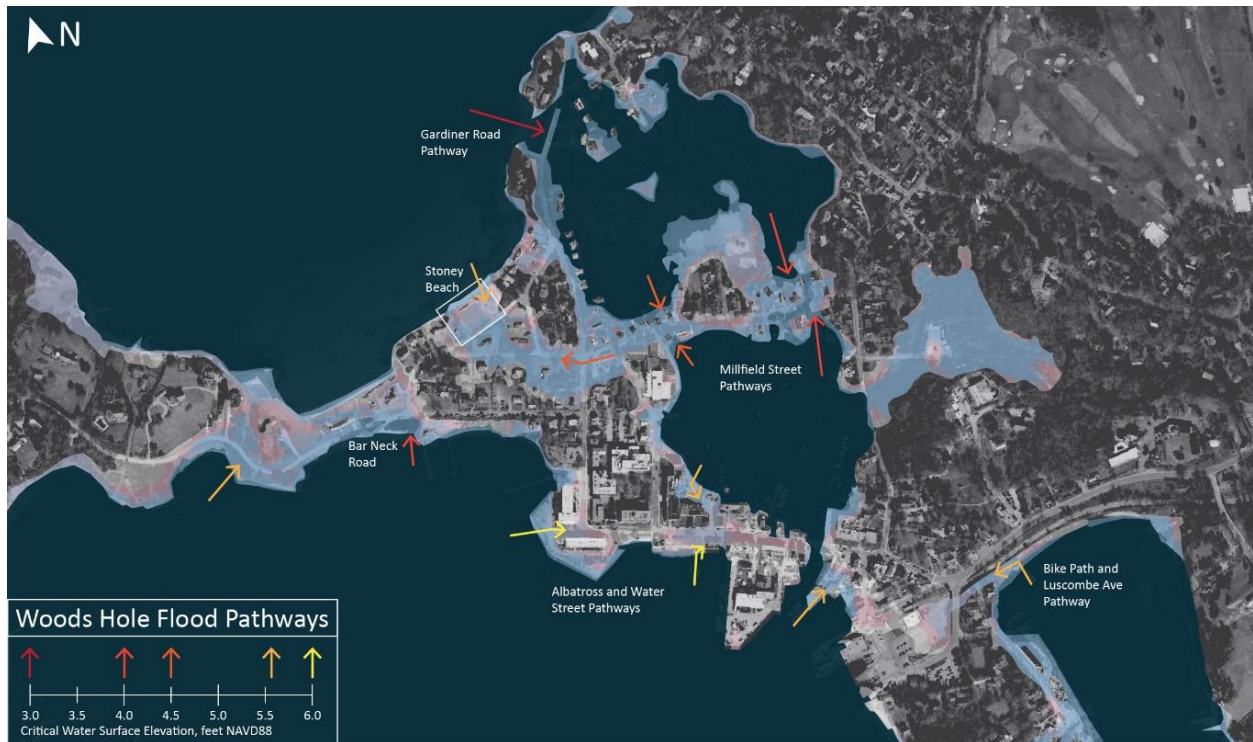
Figure 1: Flood pathways in Woods Hole.

A flood pathway is a route that allows coastal floodwaters to propagate landward through lower elevation conduits, potentially exposing larger inland areas to coastal flooding. In the Woods Hole area, major flood pathways include the low-lying marsh area behind the Gardiner Road seawall (wave overtopping at shore protection structures can contribute large volumes of water that flows to nearby areas), low spots along Millfield Street coincident with culverts between Eel Pond and the Mill Pond wetland system, and portions of the Stoney Beach dune that have been lowered by foot traffic and natural erosion (Figure 1). Understanding these flood pathways is crucial for developing effective flood mitigation strategies and enhancing the resiliency of the area.

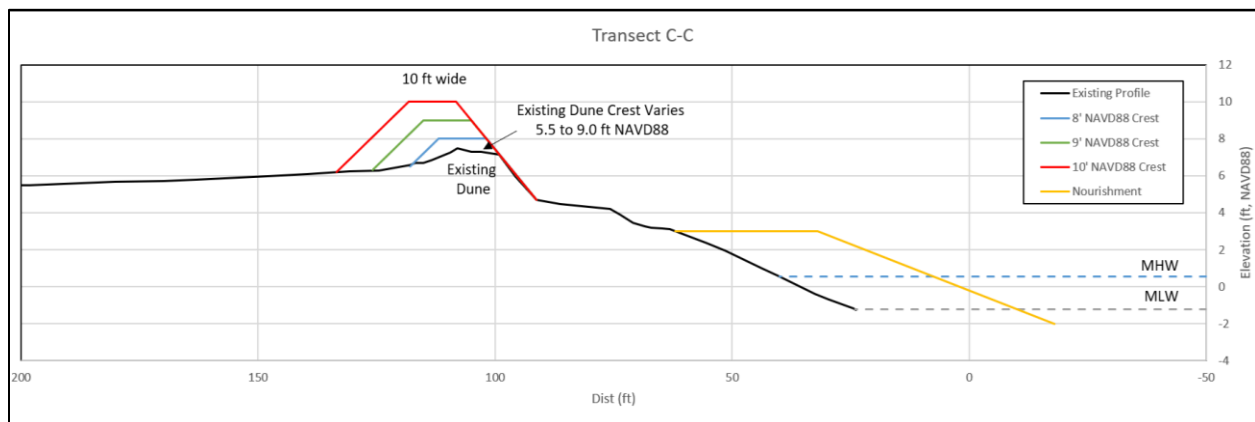
Figure 5: Cross-section of Stoney Beach showing the dune restoration and beach nourishment designs considered for the project.

The design for the dune restoration considered the existing dune elevations and surrounding landscape. Based on elevations on the adjacent property to the east, it was determined that the maximum dune crest elevation that can fit on site and tie-in with existing grades on the adjacent property is 10 ft NAVD88. As such, three different dune crest elevations of 8, 9, and 10 ft NAVD88 were selected for the evaluation. The 10 ft NAVD88 dune crest was the largest that could be built on site and still tie-in with the neighboring property, while the 8 ft NAVD88 would essentially fill low spots at the access paths, and the 9 ft NAVD88 dune crest would represent an intermediate scenario. Dune crest widths of 10 ft were incorporated into each of the designs. This width created a dune that could withstand some erosion along the seaward face without breaching, and also avoided encroaching on the parking lot. The analysis also considered the benefits of adding beach nourishment. The nourishment design included a berm at elevation of 3.0 ft NAVD88 extending seaward 30 ft, and then sloping down gradually at a 10H:1V slope (equivalent to the natural slope of the existing beach) to meet existing grade (Figure 5). The design increased the width of the beach above the high tide line and also allowed the nourishment material to be contained in the area between the two groins, decreasing the potential for loss of material to adjacent beaches.

- Concern about loss of usable recreational beach area to dune replenishment, and discussion of tradeoffs of locating the dune further landward on the parcel at the expense of parking and amenities
WHG Response: as shown in Figure 5, the dune replenishment would build landward from the toe of the existing dune and not encroach on the existing beach berm...further, the recommended beach nourishment to extend the life of the dune would also increase the size of the useable beach

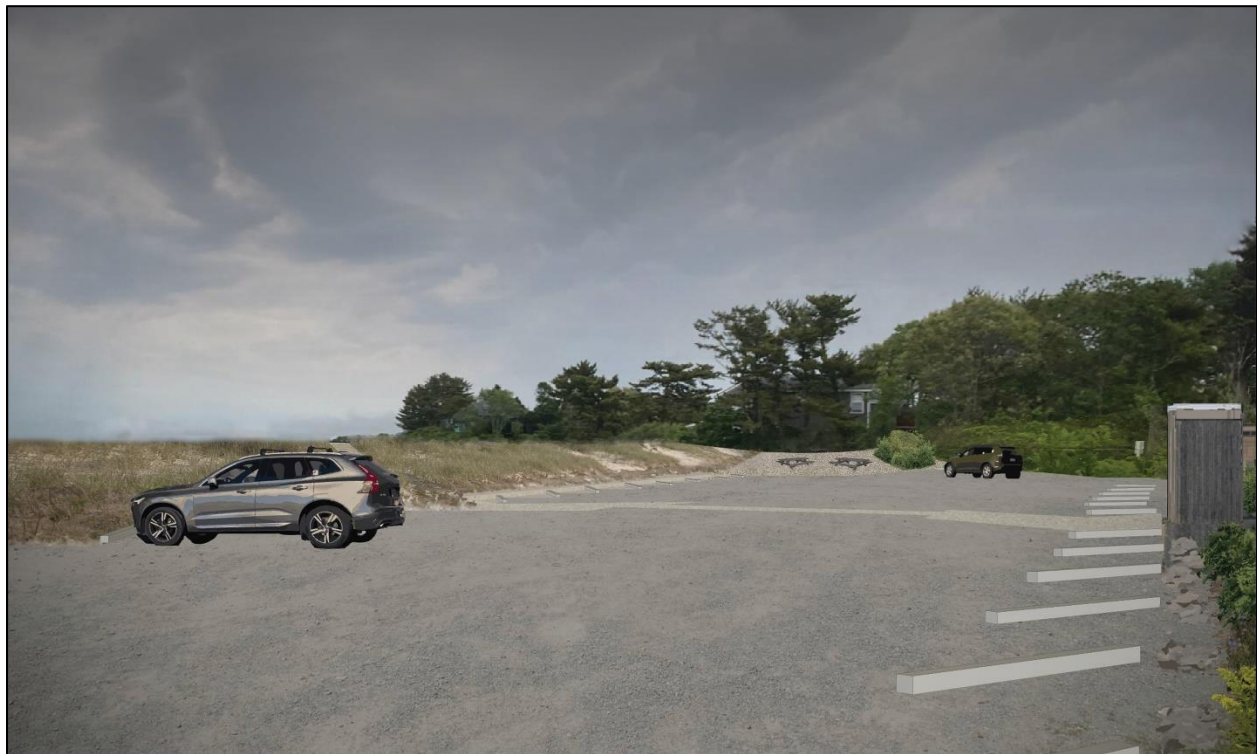
Figure 14: Rendering of Option 2 from middle of the parking lot looking east.

Option 2: In this option, the parking lot redesign involves expanding its west-east extension and moving the northern boundary southward (Figure 13). This adjustment provides space for the dune to be designed with a gentler backslope and to naturally migrate landward in the future. Diagonal parking spaces would reinforce the proposed one-way traffic pattern, with vehicles entering through the eastern and exiting on the western side of the parking lot. The parking lot would be graded to allow stormwater to collect in a vegetated swale near Gosnold Road. A separate pedestrian entrance would cross the vegetated swale. Additionally, accessible parking spaces could be located next to the Mobi-Mat, providing the public with a seamless access point to the beach. This option includes a total of 30 parking spaces. Figures 14 and 15 show 3D renderings of Option 2.

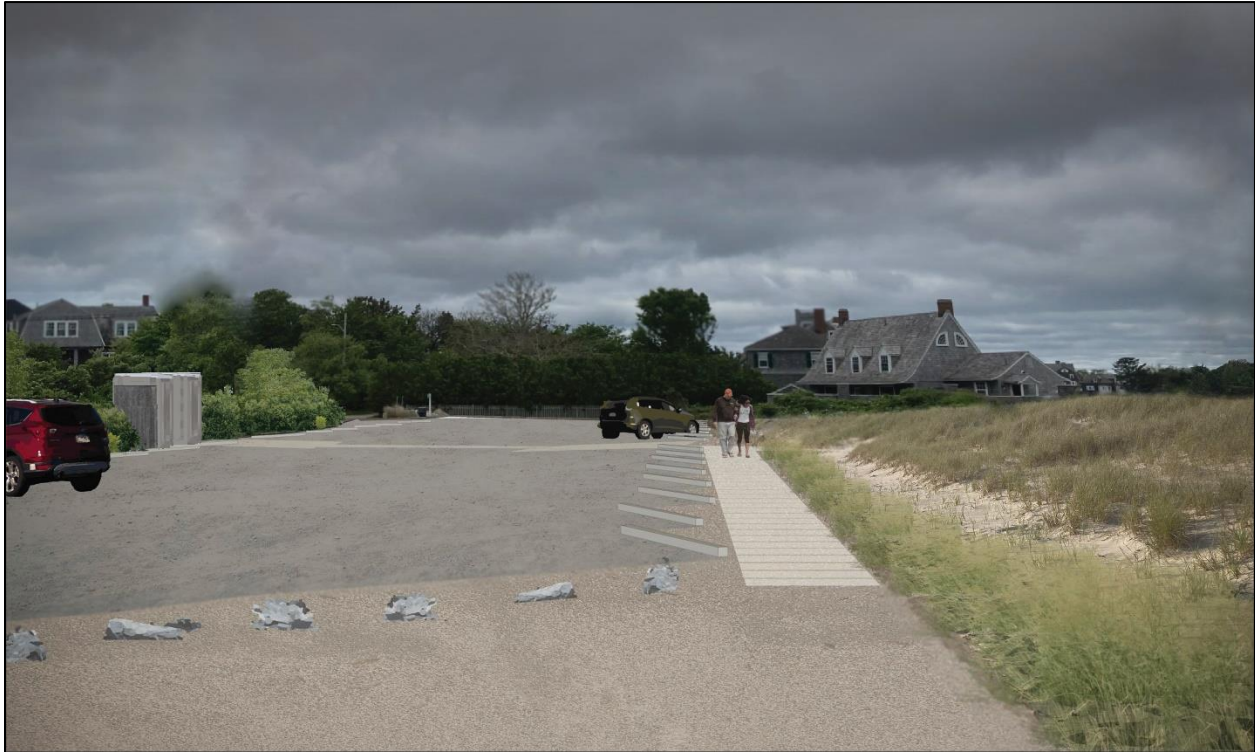
Figure 15. Rendering of Option 2 from middle of the parking lot looking west.

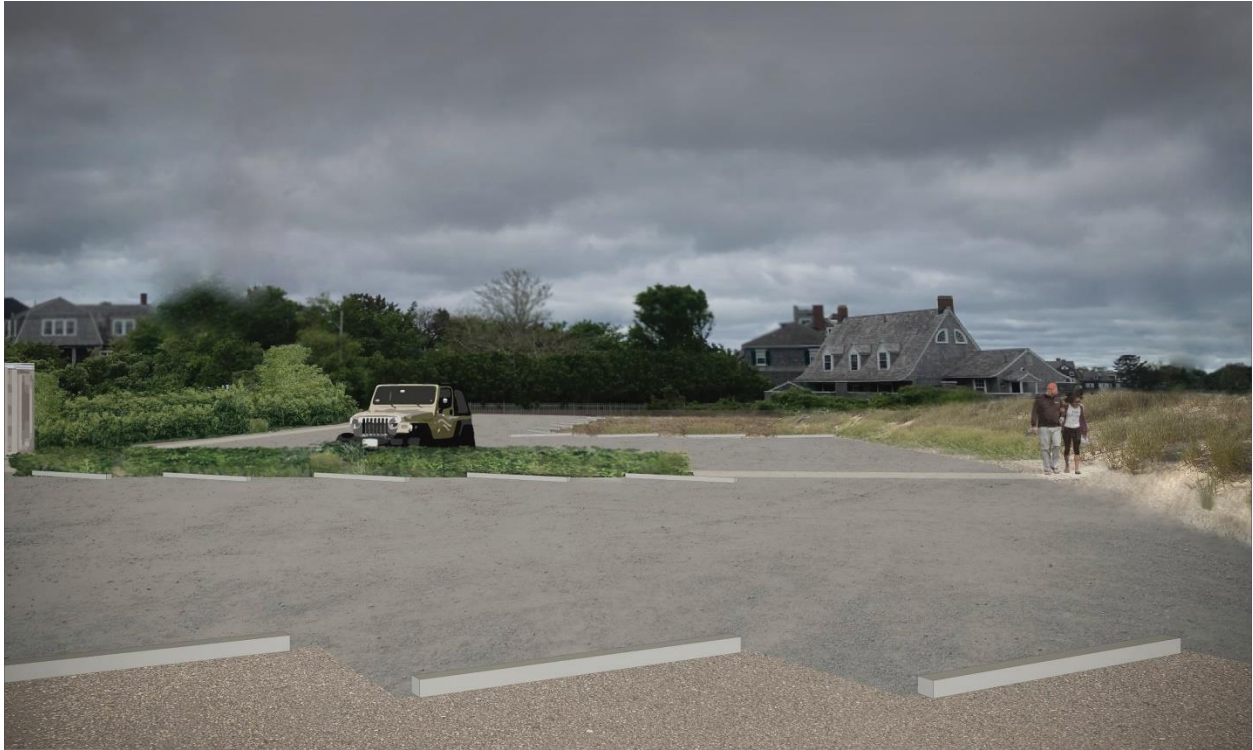
Figure 18: Rendering of Option 3 from middle of the parking lot looking west.

Option 3: This option also includes a parking lot redesign but is shaped differently. The parking lot would be graded to allow stormwater to collect in a vegetated swale near Gosnold Road. A separate pedestrian entrance from Gosnold Road would cross the vegetated swale. Diagonal parking spaces would reinforce the proposed one-way traffic pattern, with vehicles entering through the eastern and exiting on the western side of the parking lot. Additionally, accessible parking spaces could be located next to the Mobi-Mat, providing the public with a seamless access point to the beach. This options allows for a total of 28 parking spaces. Figures 17 and 18 show 3D renderings of Option 3.
